Contract #: 04-0120F4Cty: SF/ALA Rte: 80 PM: 13.2/13.9File #: 13.28**WELDING INSPECTION REPORT****Resident Engineer:** Pursell, Gary**Address:** 333 Burma Road**City:** Oakland, CA 94607**Report No:** WIR-010048**Date Inspected:** 06-Nov-2009**Project Name:** SAS Superstructure**OSM Arrival Time:** 700**Prime Contractor:** American Bridge/Fluor Enterprises, a JV**OSM Departure Time:** 1530**Contractor:** Oregon Iron Works Clackamas, Or.**Location:** Clackamas, OR**CWI Name:** Mike Gregson, Jose Salazar**CWI Present:** Yes No**Inspected CWI report:** Yes No N/A**Rod Oven in Use:** Yes No N/A**Electrode to specification:** Yes No N/A**Weld Procedures Followed:** Yes No N/A**Qualified Welders:** Yes No N/A**Verified Joint Fit-up:** Yes No N/A**Approved Drawings:** Yes No N/A**Approved WPS:** Yes No N/A**Delayed / Cancelled:** Yes No N/A**Bridge No:** 34-0006**Component:** Hinge K Pipe Beams**Summary of Items Observed:**

Hinge-K Pipe Beam Assembly 102A-3: 11/6/09

Hinge-K Pipe Beam Assembly 102A-4: 11/6/09

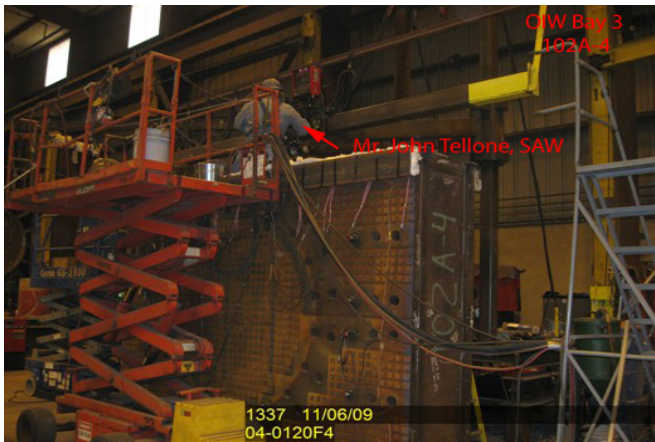
QA Inspector noticed this assembly 102A-4 had been previously placed in position and welder #T23, Mr. John Tellone, was in process of performing submerged arc welding, on the a109 Post Tension Cap plate to a106

stiffener, designated as weld joint # W2-19, in the flat position. QA Inspector noted that this weld joint was designated as partial joint penetration (AWS D1.5 TC-P4-S) and QA Inspector verified Mr. Tellone was currently qualified for this process/position. QA Inspector noted that Mr. Tellone was utilizing OIW approved welding procedure specification (WPS 4020) and randomly recorded pre-heat temperatures of approximately 350 degrees Fahrenheit (177 C). QA Inspector noted that QC Inspector Jose Salazar was present to monitor in-process welding parameters (amps/volts) and Mr. Gregson had previously recorded in-process welding parameters of 565 amps and 35 volts, during the welding cover passes, which appeared to be in compliance with the applicable welding procedure specification and AWS D1.5. See attached picture below.
